WATER SUPPLY, SANITATION AND WASTEWATER MANAGEMENT: PROGRESS AND PROSPECTS TOWARDS CLEAN AND HEALTHY SOCIETY

Symposium Proceedings 23 June 2008, Peradeniya, Sri Lanka

PROCEEDINGS OF A SYMPOSIUM

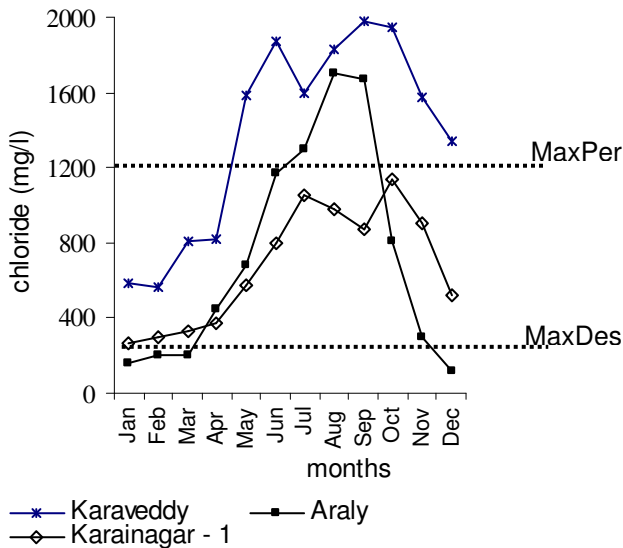
Figure 2: Temporal variation of chloride.

Figure 2 shows temporal fluctuation of chloride concentration at selected water supply wells. Even though average chloride concentration was less than the permissible level of SLS, some of the months values were exceeded the level. The high chloride concentration was observed in dry period. The above phenomena clearly shows the over drafting of water supply from these two (Karaveddy and Araly) supply wells and high evaporation during dry period.

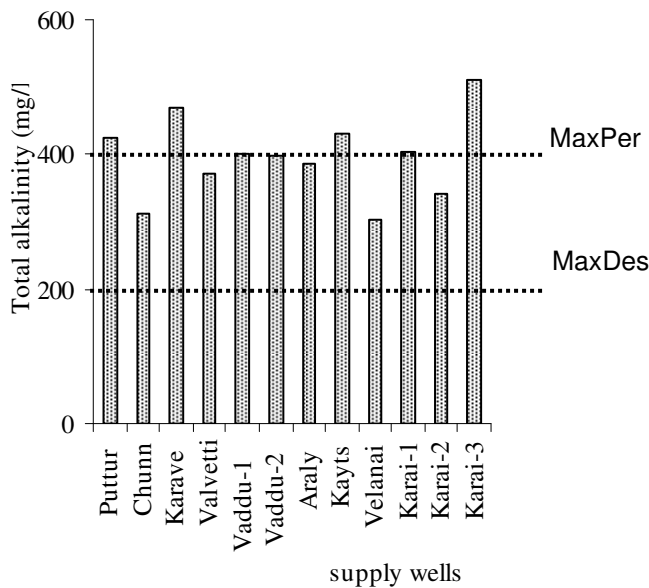
Figure 3: Average total alkalinity of all supply wells.

The Alkalinity measures the presence of bicarbonate, carbonate or hydroxide constituents. The result revealed that the total alkalinity values of water supply wells varied from 100 mg/l to 1000 mg/l. The average alkalinity value and temporal variations were shown in Figures 3 and 4 respectively.

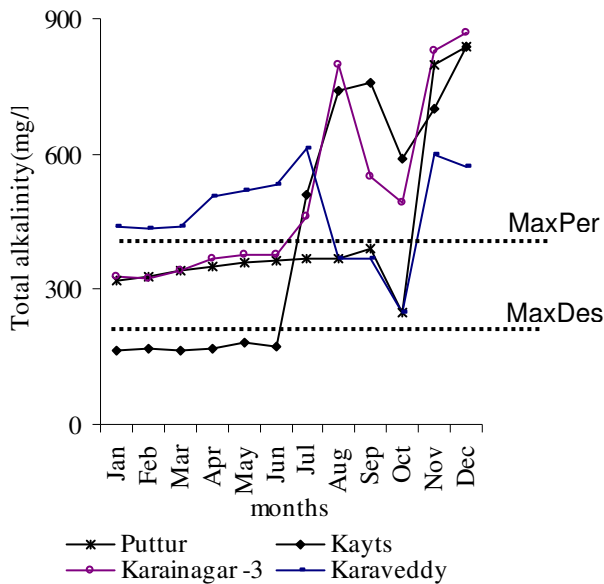
Figure 4: Temporal variation of total alkalinity.

The total alkalinity values of all water supply wells were below maximum permissible level during dry period and above permissible level during wet period. Most of the water supply wells had the peak total alkalinity values during wet period in which relatively a higher proportion of leaching would occur. As a result, the concentration of carbonates, bicarbonates and hydroxides would increase above the standard levels.

Based on the recommendation of SLS, only well at Karainagar (well 2) was satisfying the requirement. All other supply wells were not at the standard for supply during wet season and Araly, Velanai, Vaddukoddai 2, Karainagar 1 & 3 and Kayts wells were not recommended during some of the months in dry season. But Karaveddy (Figure 4) well was not recommended even during driest period.

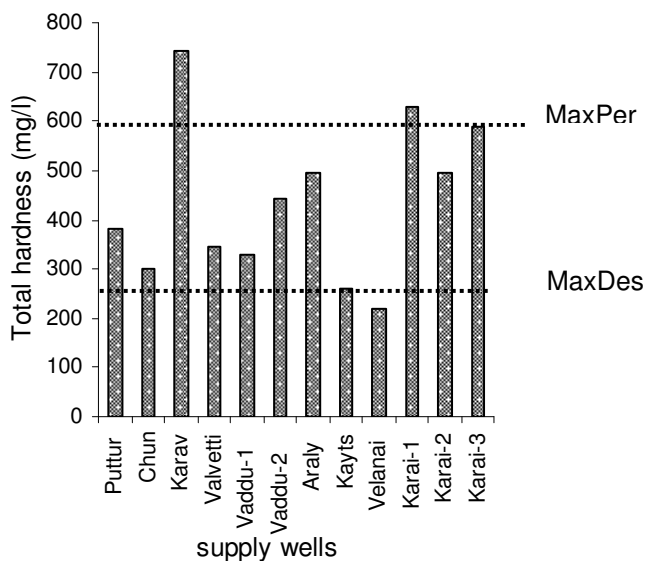
Figure 5: Average hardness values of all supply wells.

Based on the average total hardness value (Figure 5), water supply wells at Karaveddy and Karainagar 1 were above maximum permissible level (600 mg/l). But according to the Public Health Groundwater Quality Standards of USA, it is better to start preventive measures when the total hardness is above 300 mg/l in drinking water wells (USEAP, 2000). Maheswaran (2003) mentioned that the Jaffna

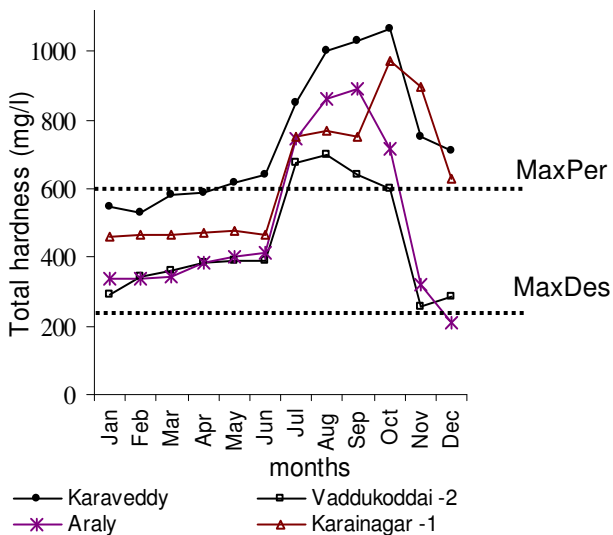
Figure 6: Temporal variation of total hardness at some supply wells.

The hardness of water relates to the amount of calcium, magnesium and sometimes iron in the water. Christopher (2006) reported that natural sources of hardness principally are limestone which is dissolved by percolating rainwater made acidic by dissolved carbon dioxide. The total hardness values of water were determined as ranging from 150 mg/l to 1100 mg/l.

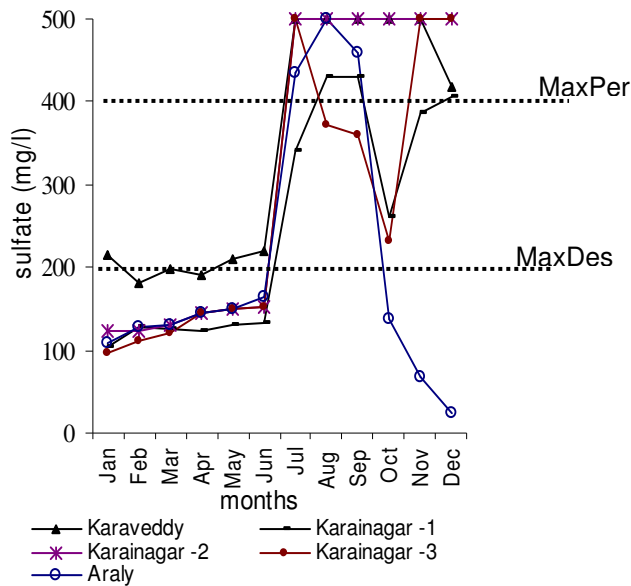
Figure 8: Sulphate values at supply wells.

Jaffna Peninsula water supply wells have the sulphate in the range from 20 mg/l to more than 500 mg/l. In the case of Karaveddy water supply well (Figure 8), concentration of sulphate was below maximum permissible level (400 mg/l) during dry period. However, sulphate concentration was above permissible level and was more than 500 mg/l during wet period. Other water supply wells were below the permissible level in all months of the year except Karaveddy, Araly and Karainagar. Kendall (1992) mentioned that sulphate content in excess of 250 to 500 mg/l may give water a bitter taste and have a laxative effect on individuals not adapted to the water. High levels of sulphate may be associated with calcium, which is a major component of scale in boilers and heat exchangers.

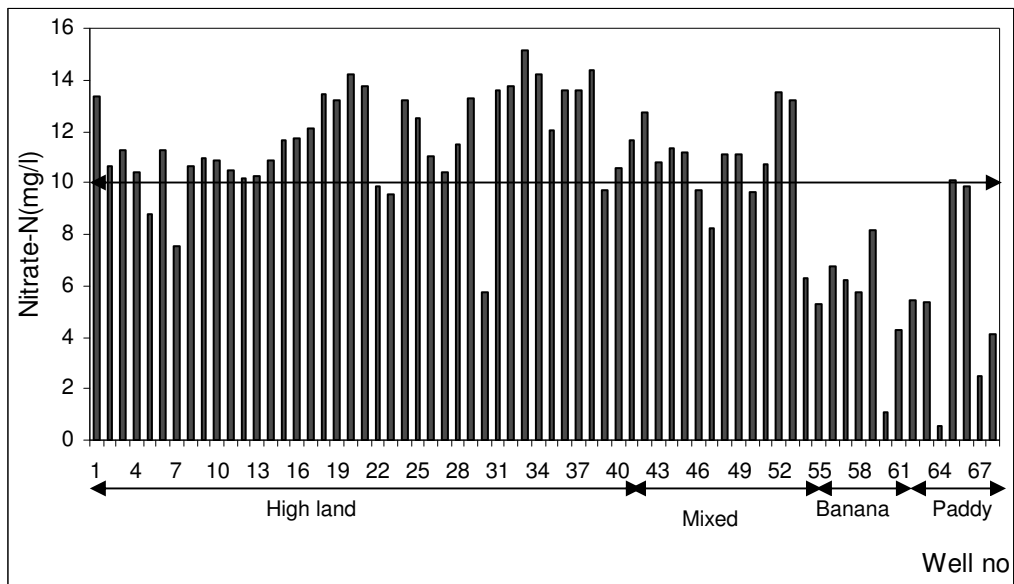
Figure 4: Average nitrate-N in the groundwater in the different land use classes.

Figure 4 shows nitrate-N in the groundwater in the different land use classes such as high land crops, mixed crops, banana and paddy. High nitrate-N concentration of groundwater was observed at high land crop land use and followed by mixed crops. Most of the wells were exceeded the recommended level for drink water standard. Concentration of nitrate –N in paddy and banana land use had less than the recommended level of 10 mg/l.

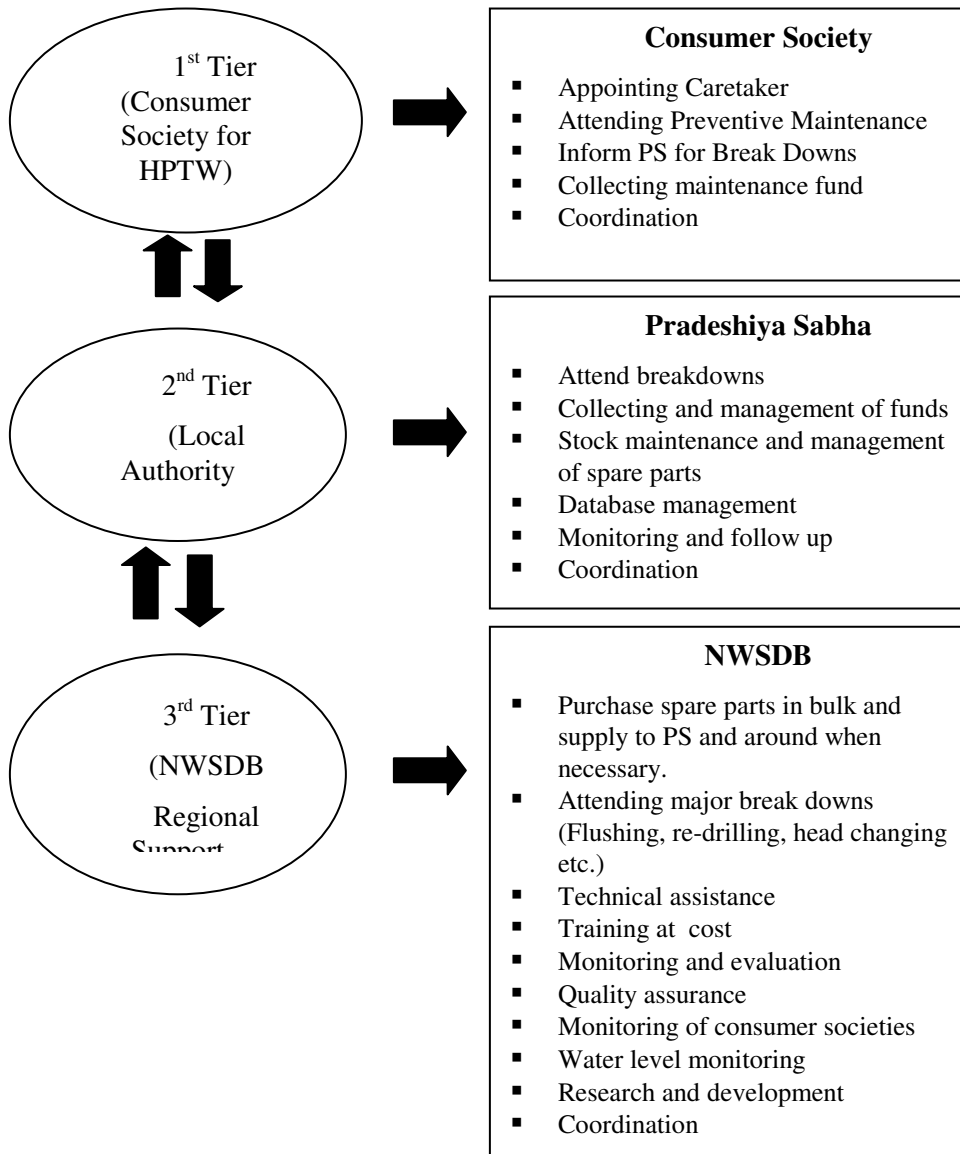
Figure 1: Implementation flow chart of 3TMS.

Existing water sources of these areas are seasonally activated. Similarly, during more than eight months of the year, the people experience dry climatic situations in these areas. During this period, water level of some HPTW depreciates and creates conflicts within the community in collecting water. According to the 3TMS policy, community participation has been supported to manage social issues to minimise conflicts and help proper water management during drought periods. User groups involve in looking after the HPTWs discuss within the respective user group about operation, maintenance, management and controlling over HPTW according to the 3TMS. It helps to strengthen the 3TMS policy in collaboration with the PS and NWSDB.

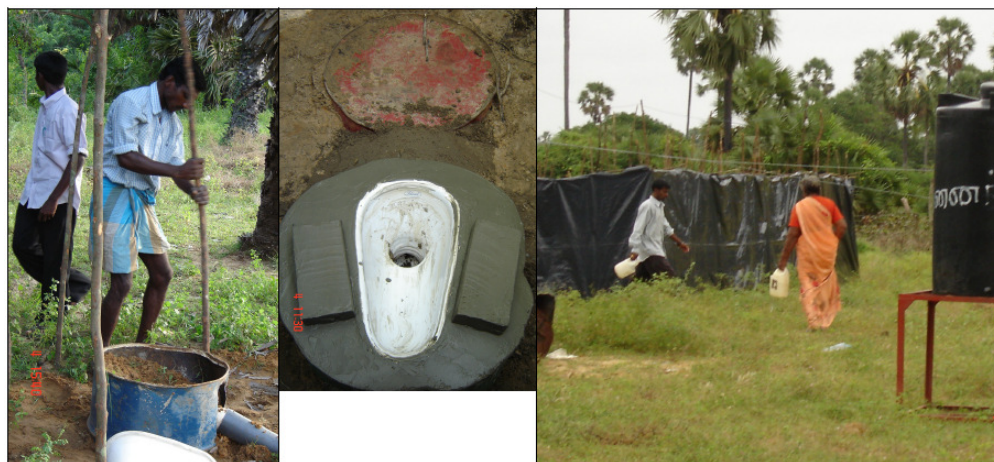
Figure 2: Constructing temporary toilets with local materials

While it is not always known how long people will stay at a certain place in emergencies, the volume of the pit does not need to be very high. If the capacity is not big enough, new toilets can be made or additional pits can be constructed. As long as the toilets are not set up too close to a well, there are no real negative impacts of these temporary toilets. If cleaning materials are provided, people can keep the toilets clean or a hygiene promotion committee needs to be organised.

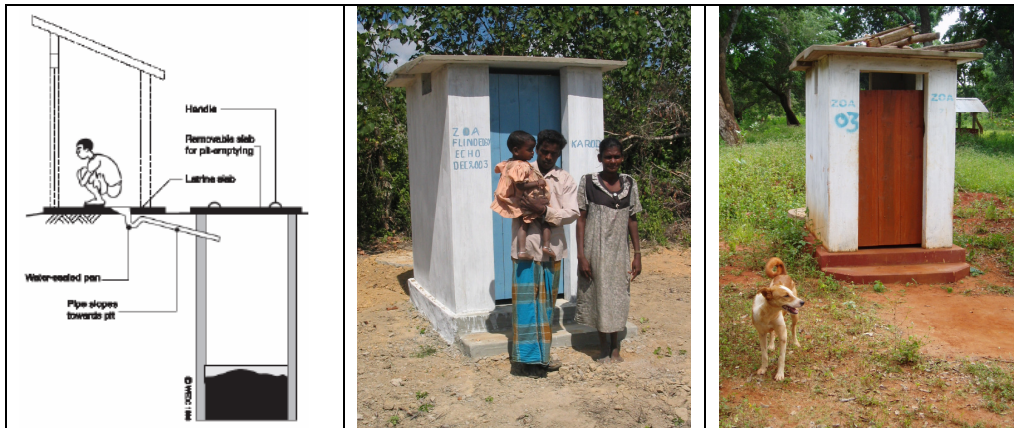
Figure 3: Pour flush toilets with soakage pit – complete with room

When the situation improves for the ordinary people, like during the CFA, rehabilitation can be started. When people return to their original places, often water and sanitation facilities are also missing. In general a private (cement block lined) well is not affordable, so for water they depend on common wells. If they build a toilet this is mostly a pour flush toilet with a simple pit. While many households, especially the extremely vulnerable households, are not in a position to construct such toilets, some programmes of the GoSL and NGOs assist them with this type of toilets.

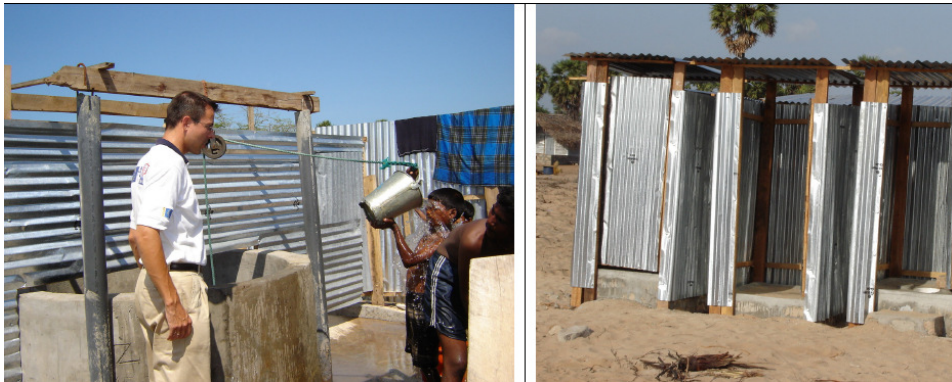
Figure 5: Semi-permanent watsan facilities in Tsunami transitional camp

For the transitional phase after the Tsunami, semi permanent watsan solutions have been provided. For example in Vaddamarachchi East and Mullaitivu per 10 families 5 toilets connected to one pit were provided. These toilets had a normal squatting pan fixed in a base of cement and were finished with a room of tin sheet. At certain transitional camps, piped water was provided from an overhead tank for drinking as well as for bathing places. ZOA Refugee Care decided to provide only water for drinking, while for bathing one well per 20 families was constructed. This was proved to be a much more sustainable solution. Less water had to be pumped from the drinking water wells (preventing water shortage and salt water intrusion problems) and the bathing water could be drawn from a larger number of wells by people themselves as they are used it. Also much less operation and maintenance was needed.
